Species and Mechanical Strengths of Wood Members in a Historical Timber Building in Gorgan (North of Iran)

Mehrab Madhoushi

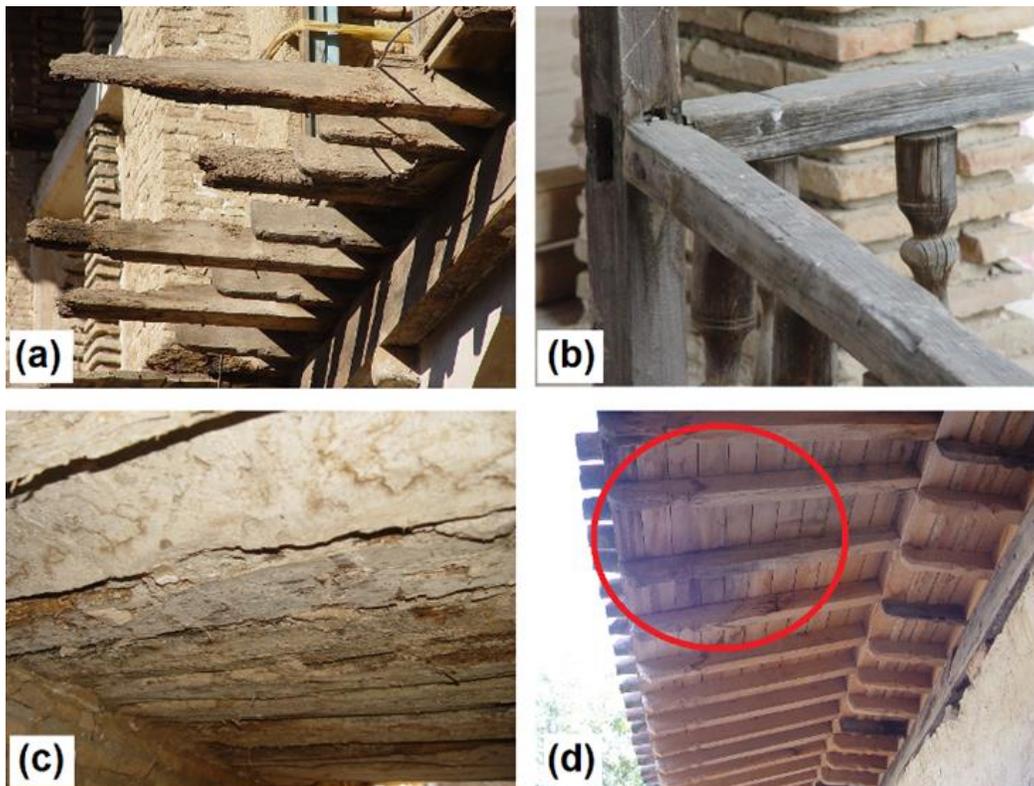
Corrosion caused by weathering (sunshine and rainwater splashing) was found in opening frames and balconies. In some parts, this was very intensive and was combined with fungal decay; the wooden elements showed significant deterioration and could not be used again (Fig. 7a). In other areas, the weathering was only a surface phenomenon (Fig. 7b), and the elements were almost at full strength, meaning that they could be used again after surface intervention. Unfortunately, this important technical issue had been ignored and new members had been utilized in large volumes. From the historical point of view, and the repair protocol, adoption of this method for restoration and repair of buildings is controversial.

With regard to the fungal and insect attack, the defects were spread across the buildings. The fungal growth and decay were mainly found on rafters and internal beams exposed to moisture flows. Decay, like weathering, depends on level of severity, and two conditions were noted: one resulting in color change, and the other, which was very intensive, resulting in strength loss. The blur was seen in an area with inadequate sun exposure and ventilation, such as internal beams (Fig. 7c). It should be noted that the substitution was lacking in a few areas where the elements were on the inside of walls.

Moisture-related problems and water penetration still remain in some of the replaced parts, leading to new stains and fungal decay (Fig. 7d). Internal holes due to insects were also found in some parts, especially where hardwood had been used. It was obvious that the insects no longer live in the wooden members; however, their effect on mechanical properties was very considerable. Although the affected members were renewed, they had not been considered in some areas, and were ignored during restoration.

Fig. 7. (a) Intensive weathering, (b) surface weathering, (c) intensive decay, and (d) moisture-related problems in new substituted members existing in the *House of Bagheri*
