Species and Mechanical Strengths of Wood Members in a Historical Timber Building in Gorgan (North of Iran)

Mehrab Madhoushi

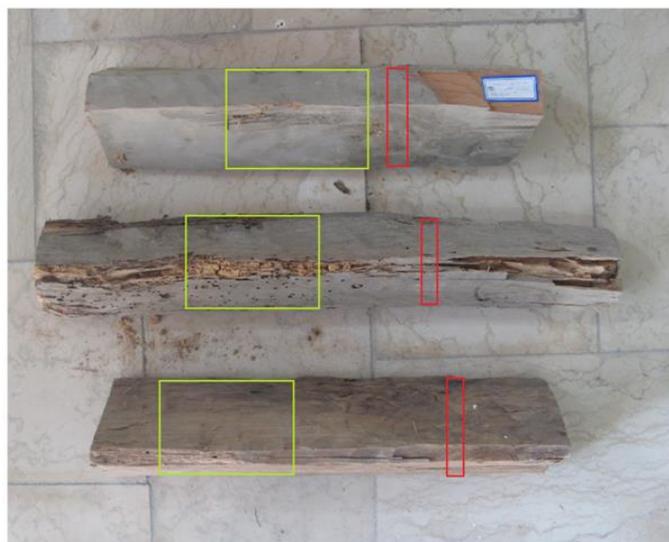
Fig. 2. An example of removed structural members and selection of parts for species identification and mechanical experiments

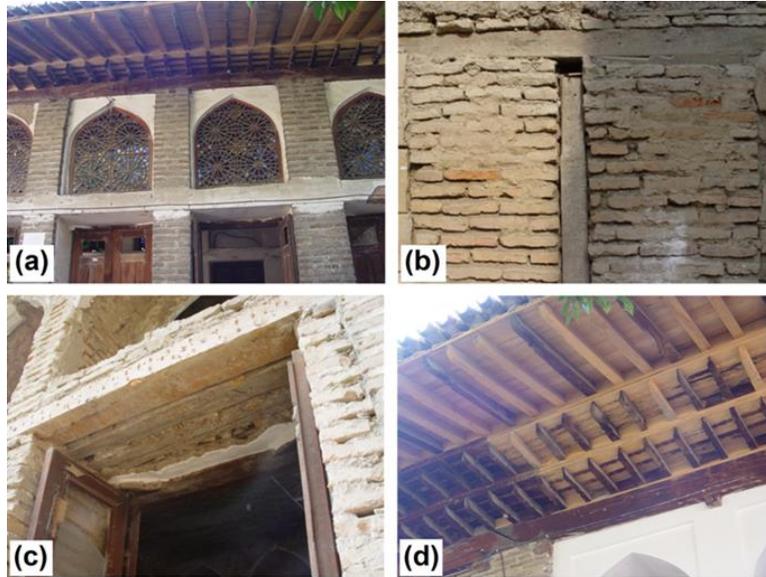
The influence of Islamic art can be observed in this building, via the dome-shaped window designs (Fig. 6a). As a result of these particular designs, air circulates easily, providing good ventilation, which in turn reduces the level of damp inside the buildings (Madhoushi and Eimanian 2008). In addition, the sunlight can reach most parts of these structures, which are rectangular in shape and were constructed of materials that were essentially brick and cob in the shear walls (Fig. 6b) and solid wood in the principal structural elements (Fig. 6c and Fig. 6d)

Fig. 6. (a) Islamic art as the dome-shaped window designs. The main construction materials used in the *House of Bagheri*, (b) brick and cob, (c) solid wood up the door, and (d) solid wood as the main beam and rafters
